11. TITLE (Include Security Classification) Rehabilitation of Navigation Lock Walls: Case Histories					
12. PERSONAL AUTHOR(S) McDonald, James E.					
13a. TYPE OF REPORT Final Report	13b. TIME COVERED FROM TO	14. DATE OF REPORT (Year, Month, Day) December 1987		15. PAGE COUNT 316

means for removing large quantities of concrete. Once the deteriorated concrete has been removed, conventional cast-in-place concrete has been used as the replacement material in most lock wall rehabilitation projects. Other replacement systems that have been used or proposed include shotcrete, preplaced-aggregate concrete, and precast concrete stay-in-place forms. In addition, several materials including latex-modified concrete, polymer mortars and grouts, conventional shotcrete, and latex-modified, fiber-reinforced shotcrete have been used as thin overlays on existing lock walls. Applications of the various rehabilitation systems and their performance to date are described in selected case histories.

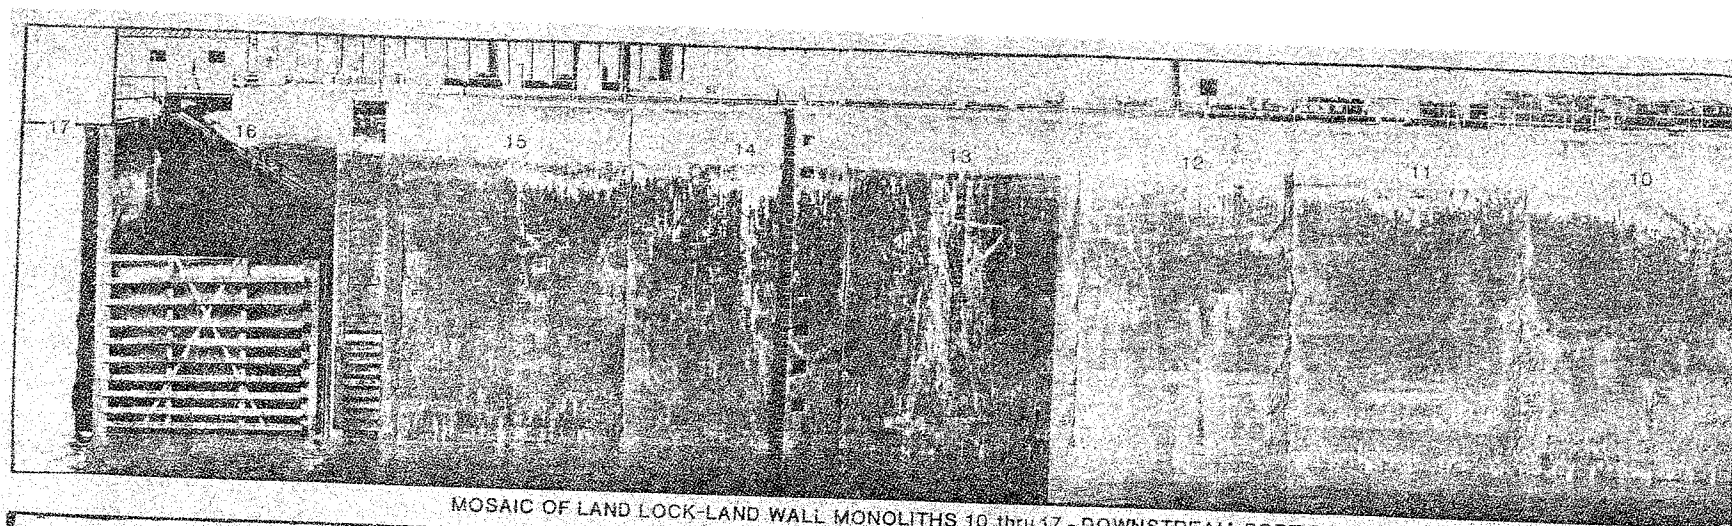
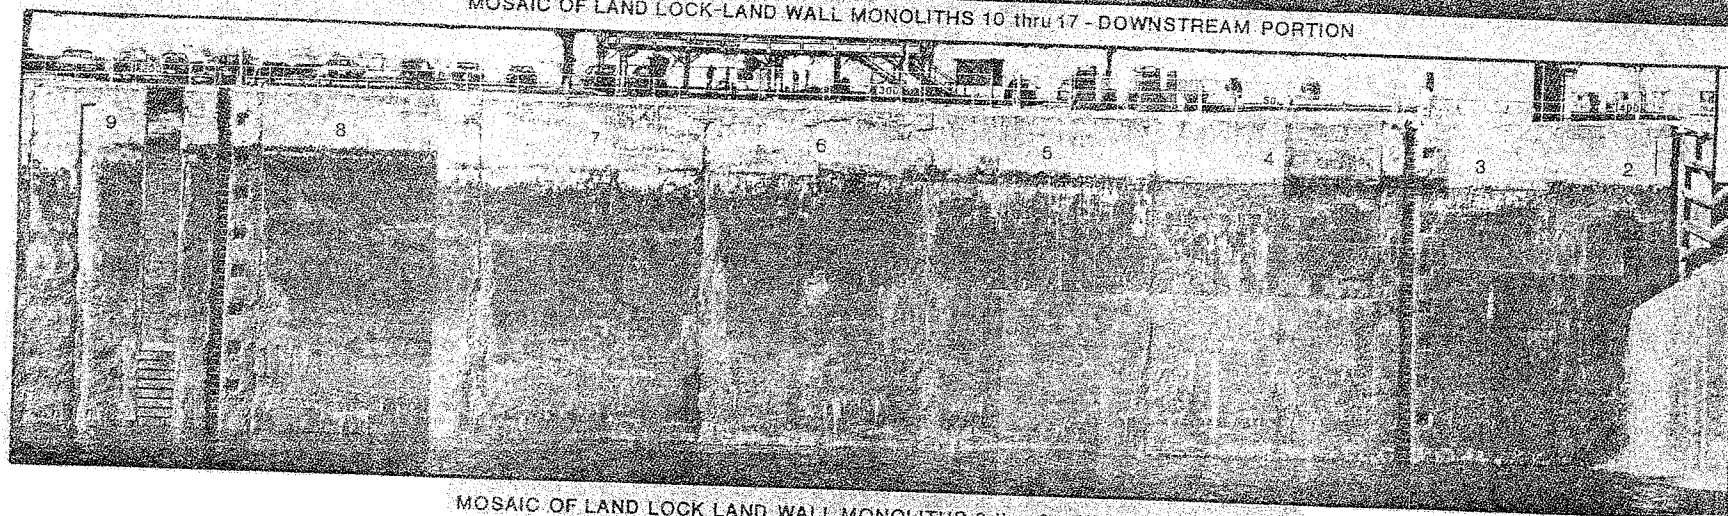
178. Based on the results of the concrete evaluations, it was concluded that the surface of the lock walls was undergoing a slow and steady deterioration from exposure to cycles of freezing and thawing. Typical concrete surface conditions are shown in Figures 82 and 83. The degree of deterioration was greater than was visually evident since there were wall surfaces which appeared sound but were deteriorated behind the surface. Such deterioration was generally characterized by laminar cracking parallel to the wall surface. The susceptibility of the lock concrete to deterioration from cycles of freezing and thawing was attributed to the degree of saturation, the lack of air entrainment, and the presence of porous chert, argillites, and microcracking as a consequence of the alkali-silica reaction or disruption of highly porous particles of coarse aggregate in the near surface zone.

179. The concrete deterioration was not confined to one area but was scattered over the entire lock surface. The surfaces most seriously affected were the top and edges of the walls and slabs, especially those above tailwater. Petrographic examinations of the concrete cores indicated wide variations in the depth of deterioration varying from 0 to 10.5 in. in the land lock and 0 to 15.7 in. in the river lock. Concrete in the walls below tailwater appeared adequately sound. Concrete in the lock floor slabs was in good condition with only superficial spalling at corners and edges. Water quality tests indicated that chemical attack on the concrete by river or groundwater was negligible at the time.

Figure 82. General condition of the land wall, land lock, prior to rehabilitation,  
Lock No. 1, Mississippi River

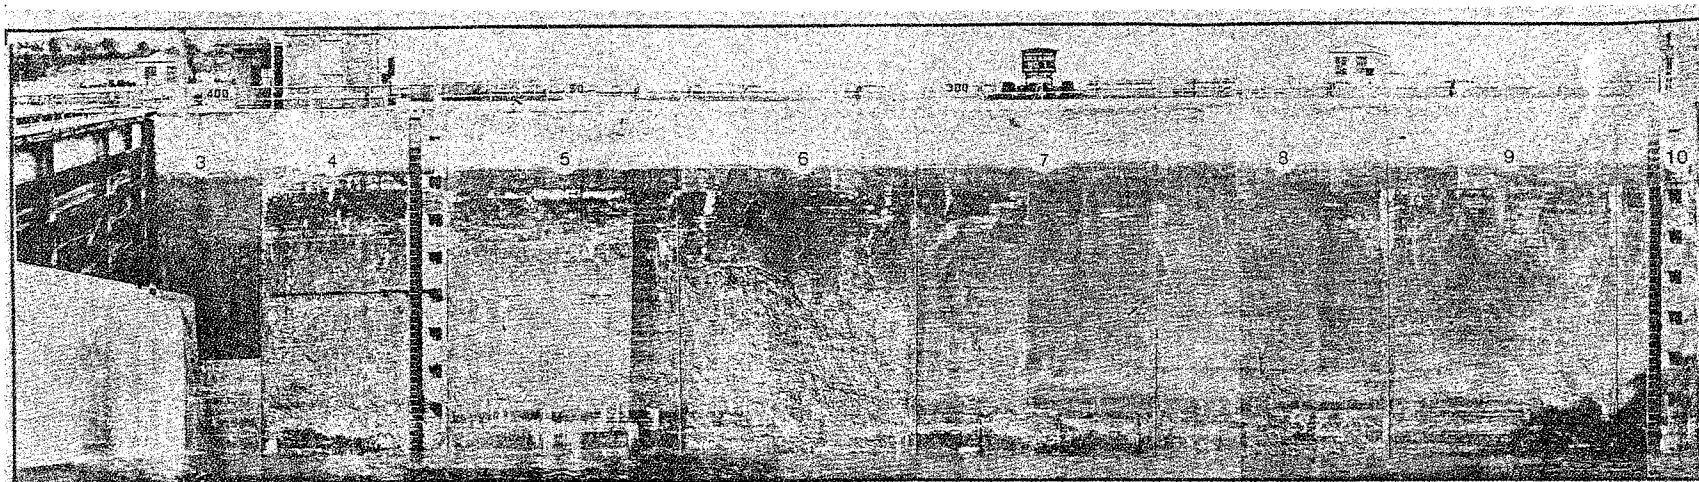
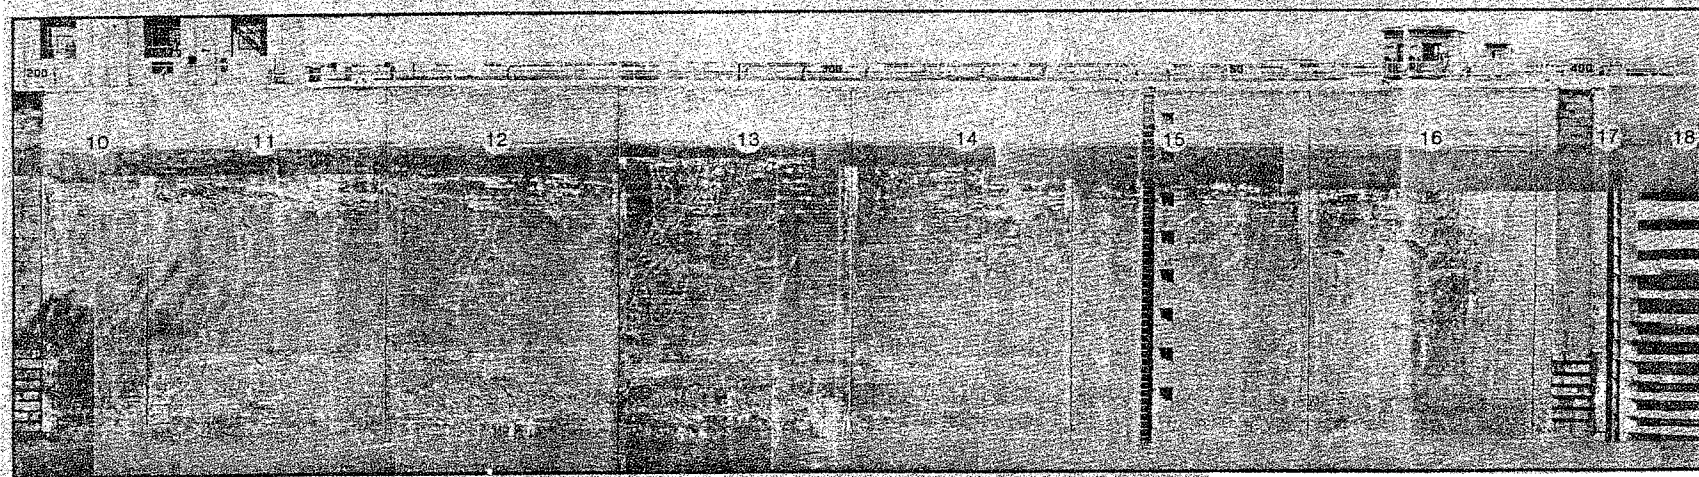
Figure 83. General condition of the intermediate wall, land lock, prior to rehabilitation, Lock No. 1, Mississippi River

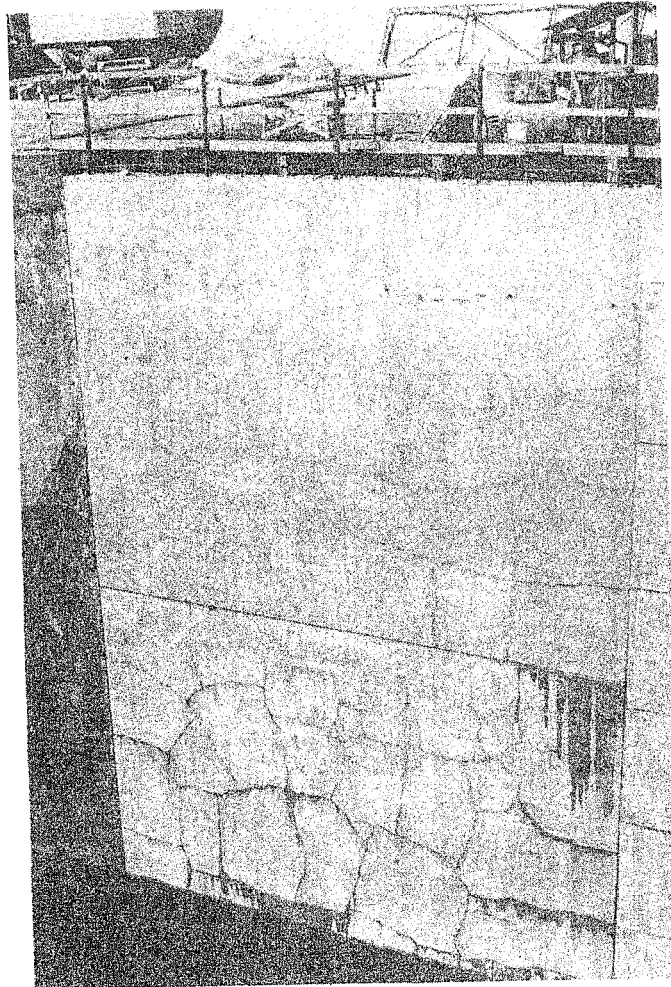
205. On 23 May, the lock chamber was flooded to low pool elevation; on 26 May, the water level was raised to the upper pool elevation. The water temperature was approximately 50 to 55°F. On 27 May, extensive cracking was observed in both lifts (Figure 89). The pattern cracks were generally spaced at 2 to 4 ft intervals. Crack widths at the surface appeared to be essentially constant, less than 0.01 in. wide. It could not be determined when cracking actually occurred, but the cracks were not observed until the lock chamber was placed into operation. Typically, cracks are much more visible after a concrete surface has been wetted since the cracks will retain moisture much longer than the surrounding concrete surface. Similarly, concrete cracking is usually more apparent following application of nonpigmented curing compound.

Figure 89. Cracking in replacement concrete,  
trial resurfacing monolith, 10 June 1980,  
Lock No. 1, Mississippi River

examination of the cores verified that good bond was obtained between old and new concrete. The examination also indicated that cracking initially developed at the face of the wall and propagated inward to approximately 90 percent of full depth of the resurfacing. There was no indication of reflective cracking although two vertical cracks at the top of lift B were in line with existing cracks in the old concrete. Results of compressive strength tests on selected cores and cylinders cast at the time of placement were as follows:

to 50°F heat rise above placing temperature. Assuming equivalent heat was generated during the trial resurfacing, a peak temperature of approximately 115°F would have been attained. Also, based on the previous curing date, it was assumed that the concrete temperature in the trial lifts was still in the 85 to 95°F range on 26 May when the lock was flooded with water having a temperature of 50 to 50°F. Therefore, the thermal shock resulting from lock flooding may have been sufficient to cause or accelerate the concrete cracking.

210. While the effects of curing temperatures, adjacent blasting, and flooding of the lock were considered highly subjective, the fact remained that by any construction standard, the concrete was left unprotected from the sun, without any curing medium being applied, for an unacceptable period of time. Therefore, the District concluded that the quality control for the trial resurfacing was such that the exact cause of the cracking could not be ascertained. Also, that the project specifications appeared to be adequate to obtain concrete with a minimum of cracking. The following procedures, all within project specifications, were considered to be especially necessary in obtaining good results for the overlay concretes:

- a. Use 1-1/2-in. maximum-size aggregate.
- b. Use a concrete mixture proportioned for 3,000-psi compressive strength with a 0.48 water-cement ratio.
- c. Reduce the amount of water-reducing agent to that recommended by the manufacturer.
- d. Use proper and timely curing methods. If membrane curing is used, patching should wait until the curing period is completed.
- e. The temperature of the fresh concrete should be as low as the project specifications allow.
- f. Thoroughly consolidate placed concrete.
- g. Use hot or cold weather placing techniques as appropriate.

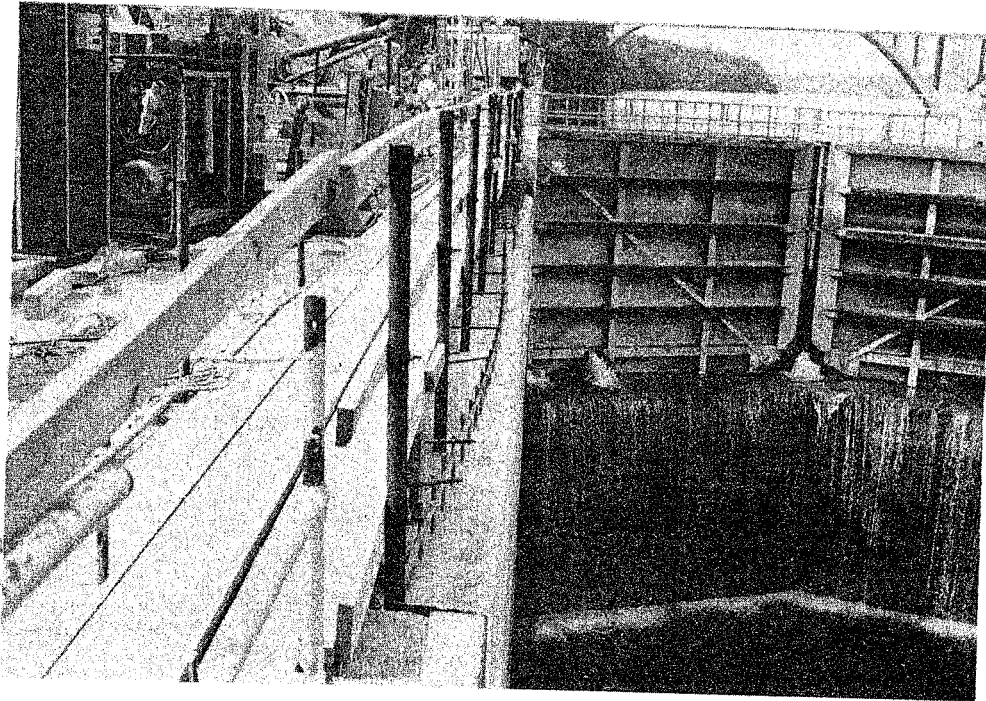
207. It was specified that temperature reinforcement be located 4-in. from the finished lock face. Concrete cores showed the reinforcing steel to be located from 6 to 7 in. from the wall face. Measurements taken after placement of lift B showed the reinforcement at the top of the lift was located from 4-1/2 to 13 in. from the lock face (Figure 90). The improperly positioned reinforcement would have provided little resistance to shrinkage and temperature stresses.

Figure 90. Location of reinforcing steel at top of Lift B, trial resurfacing monolith, 9 July 1980, Lock No. 1, Mississippi River

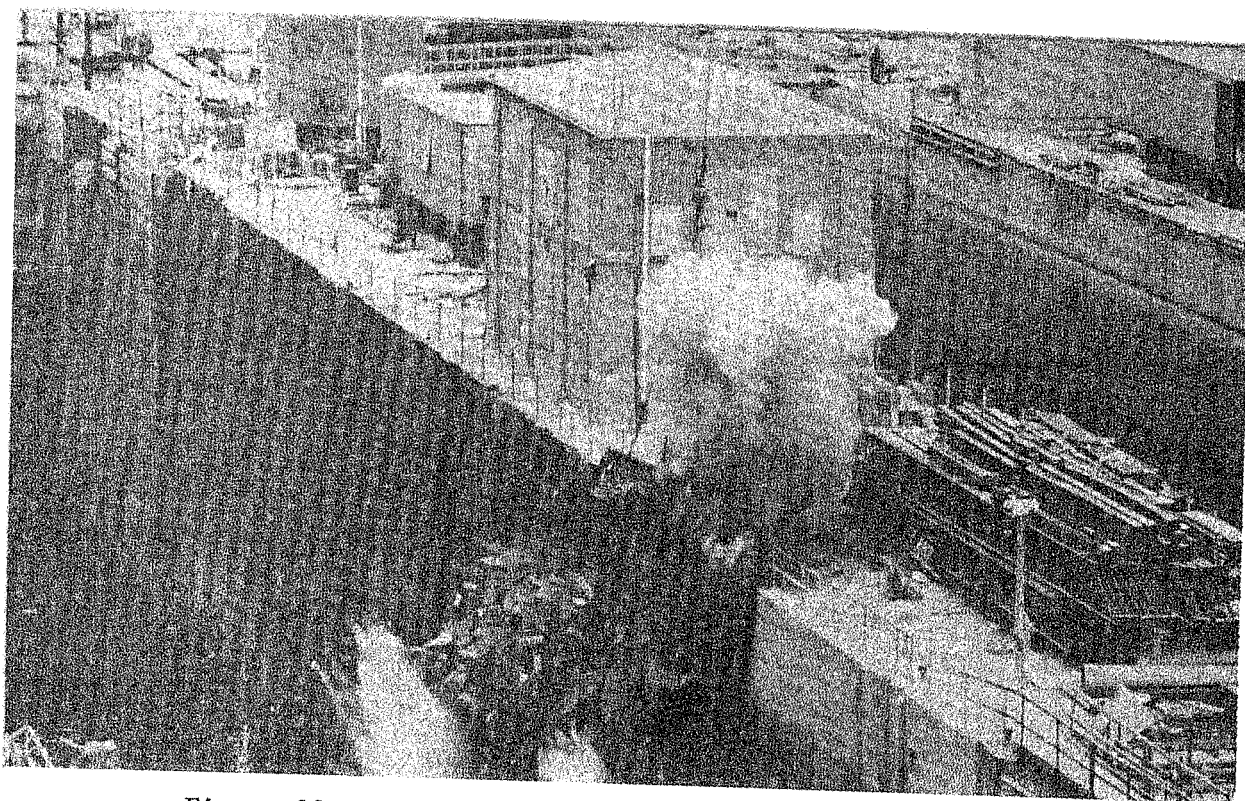
214. Results of the vertical wall removal (Figure 92) varied with respect to the condition and composition of the concrete being removed. Where excessive embedded form tie steel existed, large displaced concrete blocks or slabs frequently remained on the wall suspended by the form tie steel

Figure 92. Concrete removal, land face of intermediate wall, Lock No. 1, Mississippi River

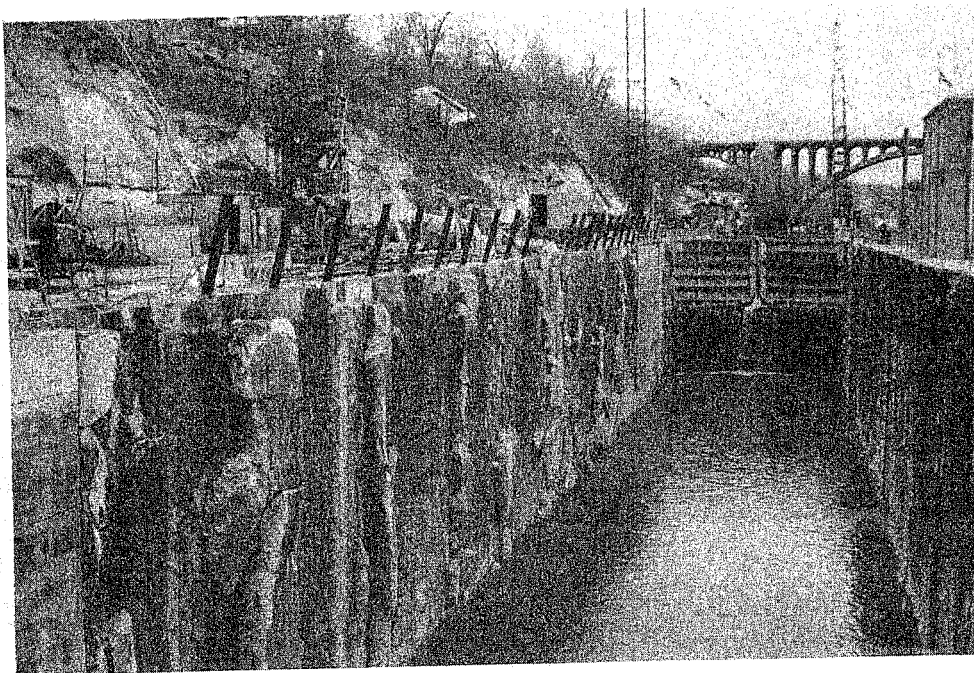
(Figure 93). These blocks occurred most frequently near the monolith joints. This hanging concrete presented a special removal problem requiring considerable removal effort by the contractor. Several "reshots" were necessary where these blocks remained, occasionally requiring even a third shot to obtain adequate removal. In an effort to alleviate this problem, the delays of some charges in the resurfacing shot were changed. However, this change came at a time when trouble causing form tie steel was no longer encountered in typical wall resurfacing blasting.

Figure 93. Hanging blocks of concrete where excessive form tie steel was encountered on the land wall, Lock No. 1, Mississippi River

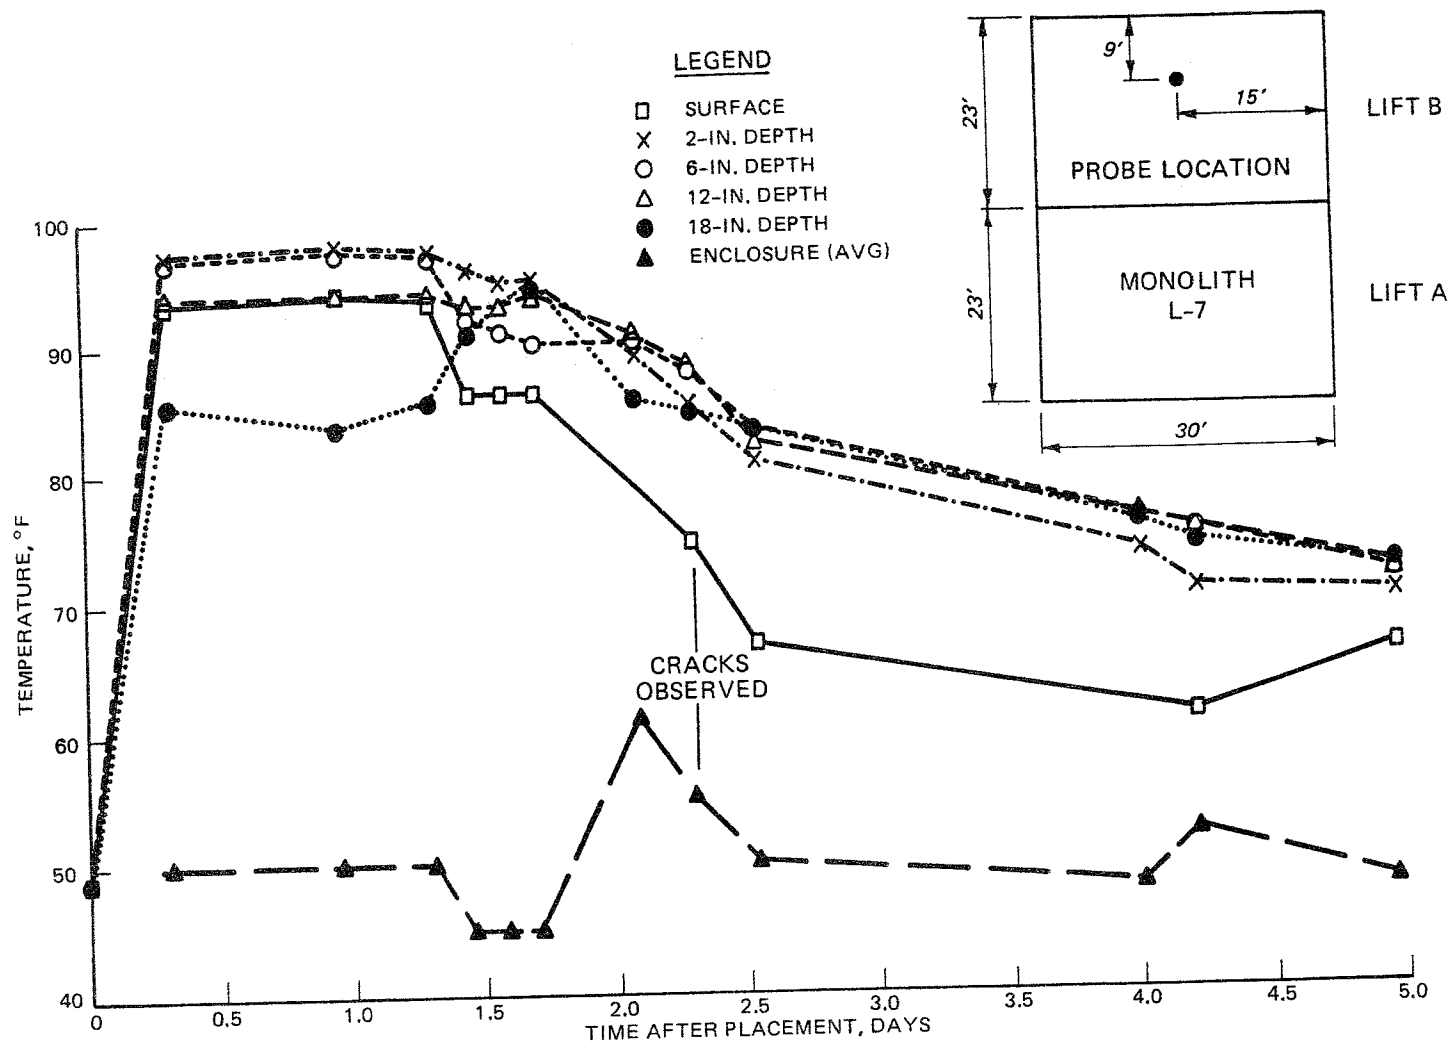
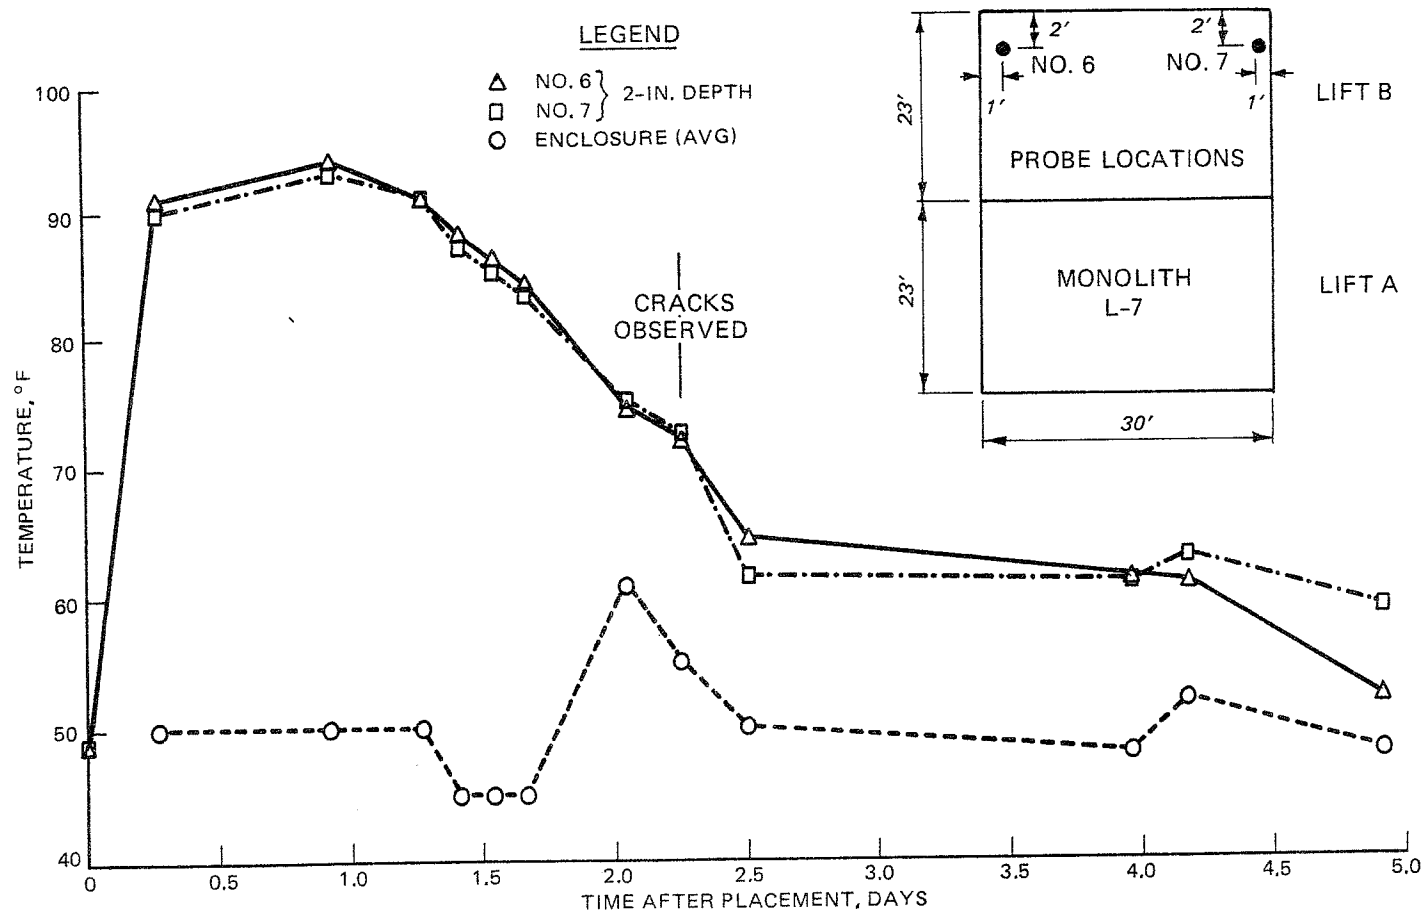
223. Results of the temperature monitoring of placement L-7B are shown in Figures 99 and 100. Although the form was not removed until 6 days after the concrete was placed, cracks were observed on top of the lift during the second day after placement. Temperature probes were located at two levels within the placement, 2 and 9 ft below the top of the lift. Peak concrete temperatures, approximately 24 hr after placement, were 95° and 98°F for the upper and lower levels, respectively, or 45° and 48°F higher than the average enclosure temperature. At the same time, the concrete surface temperature on top of the lift was reported to be 68°F. At the time cracks were observed, the temperature differential between ambient and concrete at 2-in. depth as measured from the wall face was 17° and 30°F for the upper and lower level probes, respectively. However, a temperature probe embedded 2 in. below the exposed top of the lift would have provided a more meaningful comparison in this case where the form was left in place for an extended period.

Figure 99. Results of temperature monitoring, mixture 510-4PA5, placement L-7B, 9 ft below top of lift B, Lock No. 1, Mississippi River

Figure 100. Results of temperature monitoring, mixture 510-4PA5, placement L-7B, 2 ft below top of lift B, Lock No. 1, Mississippi River

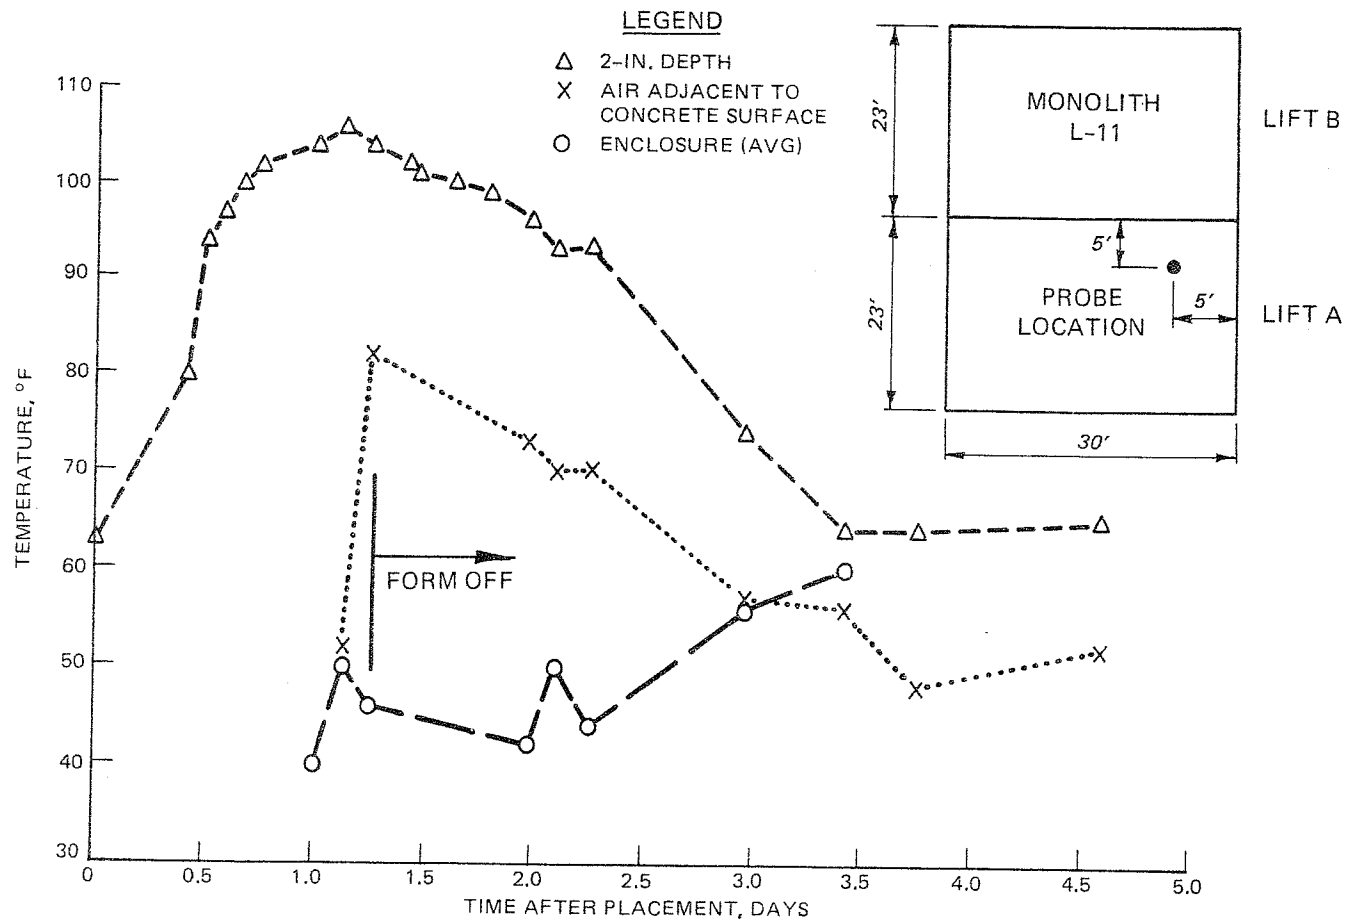
224. Results of temperature monitoring of placement L-11A are shown in Figure 101. A peak temperature of 106°F was recorded, 27 hr after placement, which represents a heat rise of 43°F. The form was removed at this point subjecting the concrete to a temperature differential between ambient and 2-in. depth of 56°F. Covering the concrete surface with polyethylene quickly

Figure 101. Results of temperature monitoring, mixture 510-4PA5, placement L-11A, Lock No. 1, Mississippi River

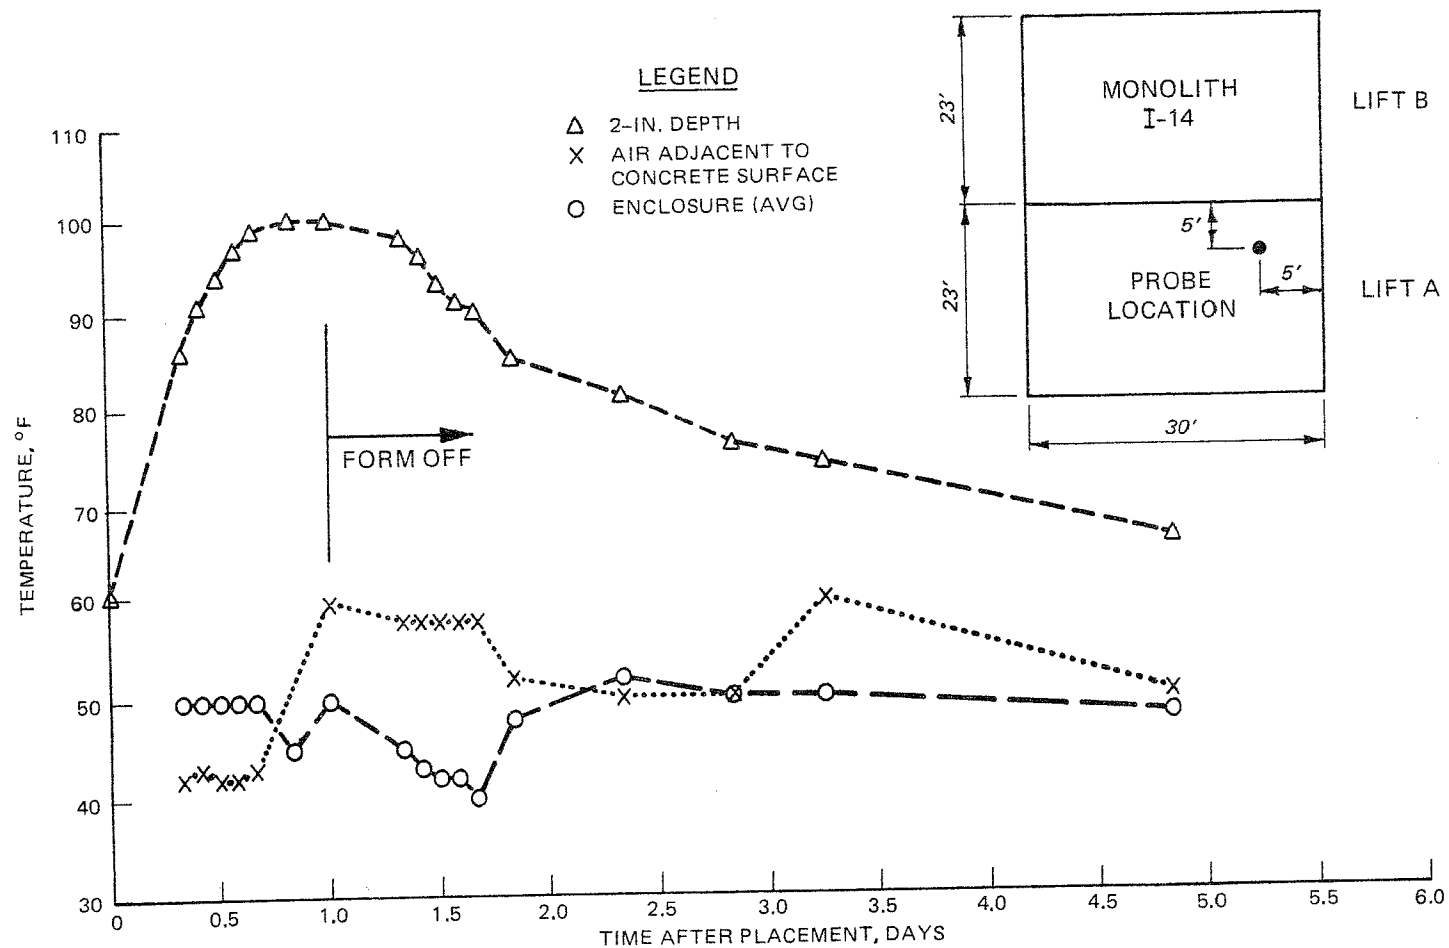
Figure 102. Results of temperature monitoring, mixture 510-4PA5, placement I-14A, Lock No. 1, Mississippi River

reduced the temperature differential between air adjacent to the surface and at 2-in. depth inside the concrete to 22°F. Similar results were obtained for placement I-14A (Figure 102). The form was removed one day following placement, subjecting the concrete to a temperature differential between ambient and 2-in. depth of 55°F. After the concrete surface was covered with polyethylene, the temperature differential between air adjacent to the surface and concrete at 2-in. depth was 40°F. This temperature differential decreased with time; however it remained in excess of 25°F for approximately two days. Although no cracks were reported for either the L-11A or I-14A placements, it is quite possible that they were present but not observed because of the polyethylene covering. Later reports that most placements contained cracks would appear to substantiate this possibility.

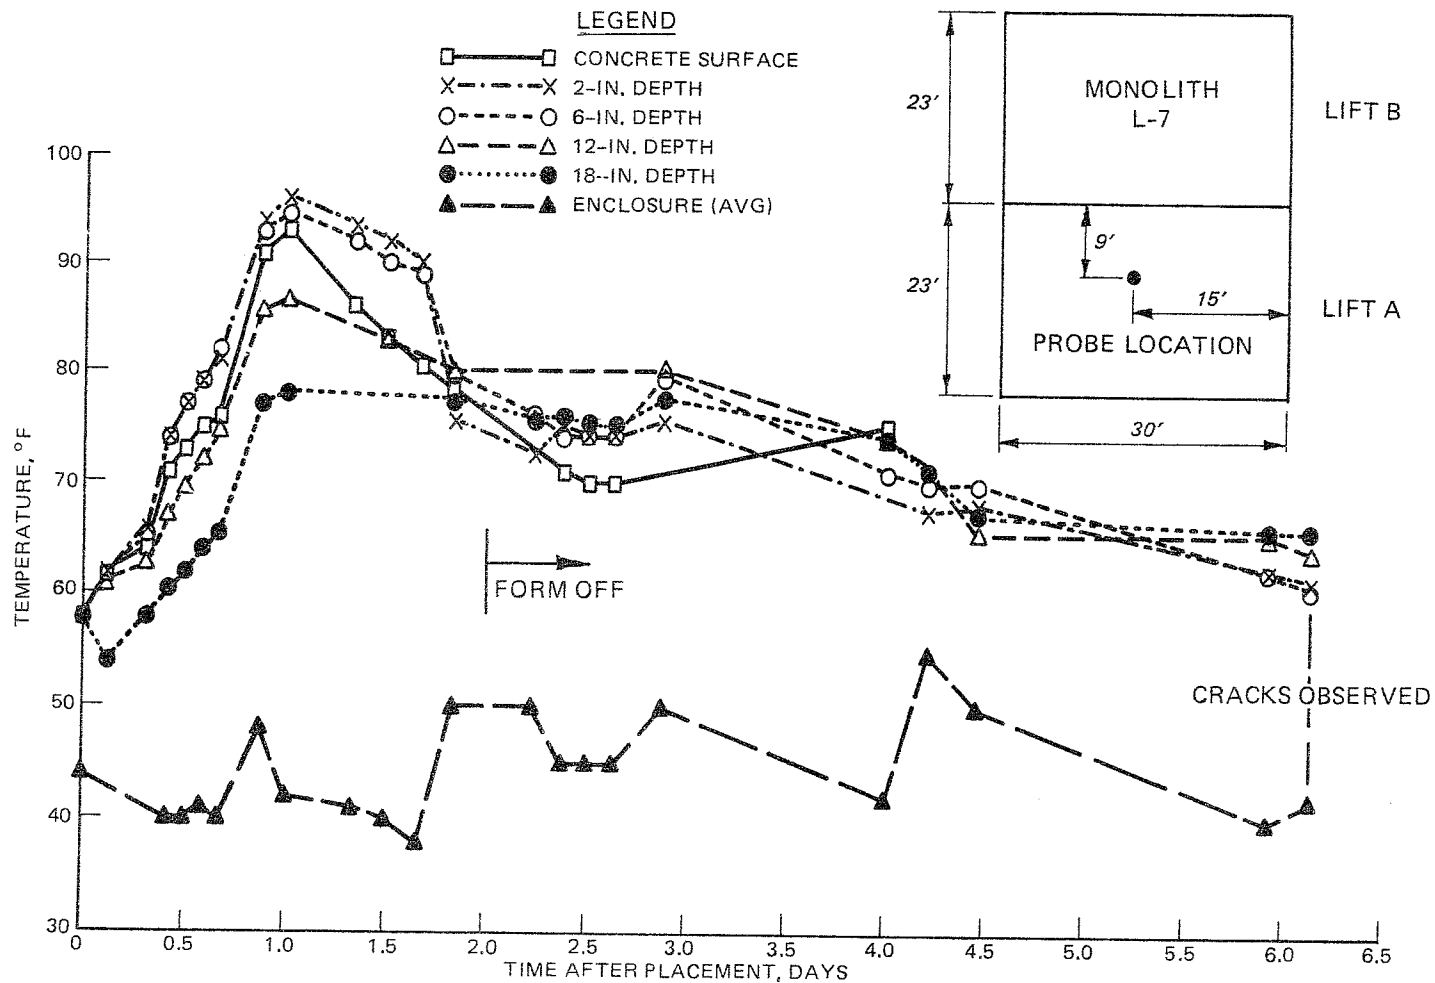
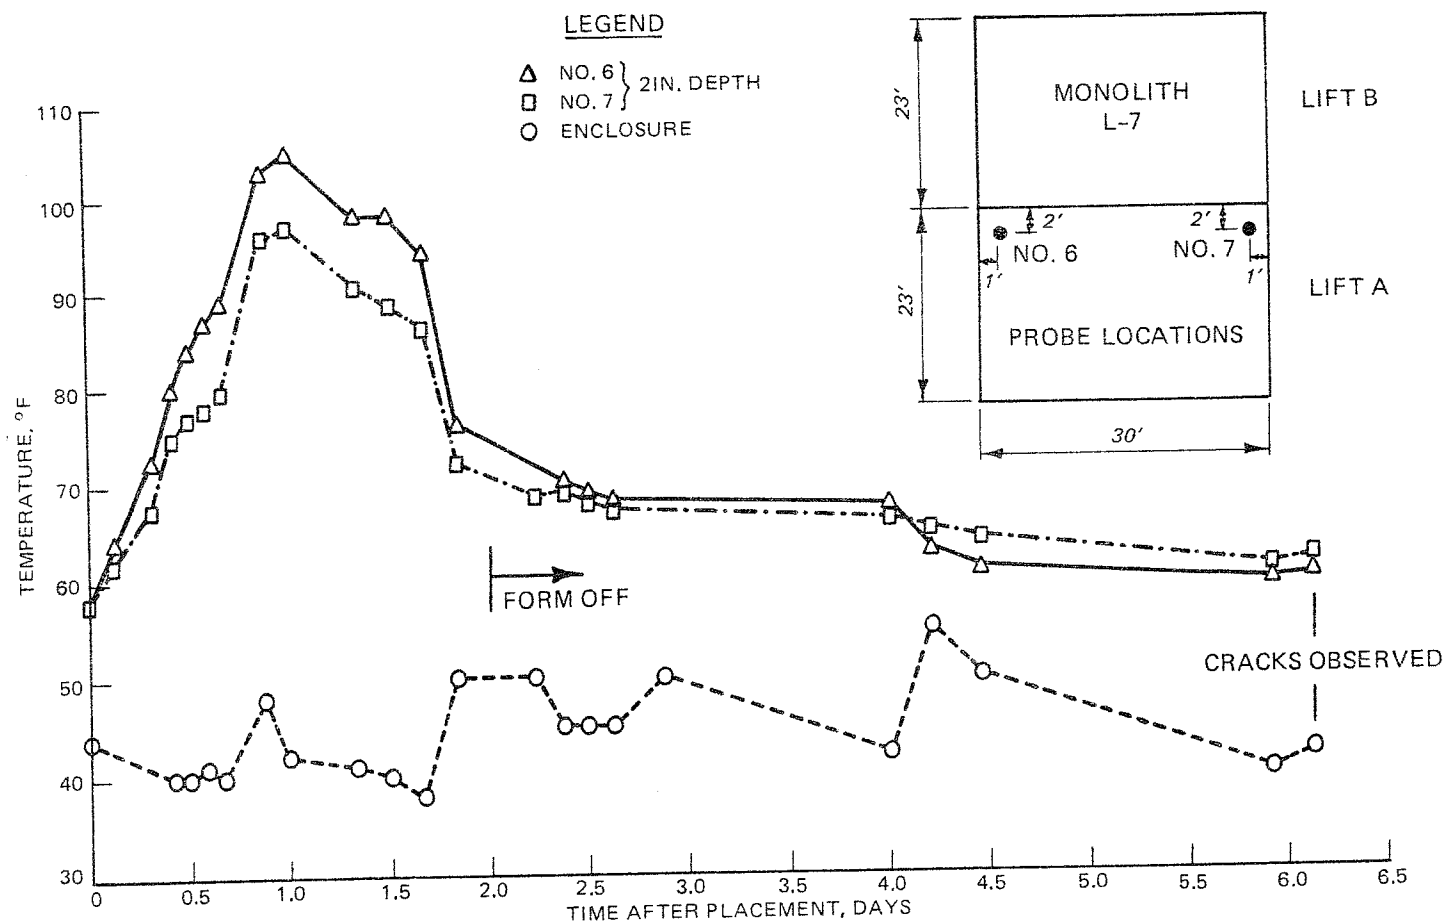
230. Results of the temperature monitoring of placement L-7A are shown in Figures 103 and 104. The peak temperature recorded, 24 hr following placement, was 96°F, which represented a heat rise of 38°F. From removal two days after placement, the concrete was subjected to a temperature differential between ambient and 2-in. depth of 25°F. This differential decreased only slightly during the remainder of the curing period. Cracking similar to that previously observed in the conventional concrete resurfacing was reported. The cracks were not observed until the end of the curing period.

Figure 103. Results of temperature monitoring, mixture CC552-4PA5, placement L-7A, 9 ft below top of lift A, Lock No. 1, Mississippi River

Figure 104. Results of temperature monitoring, mixture CC552-4PA5, placement L-7A, 2 ft below top of lift A, Lock No. 1, Mississippi River

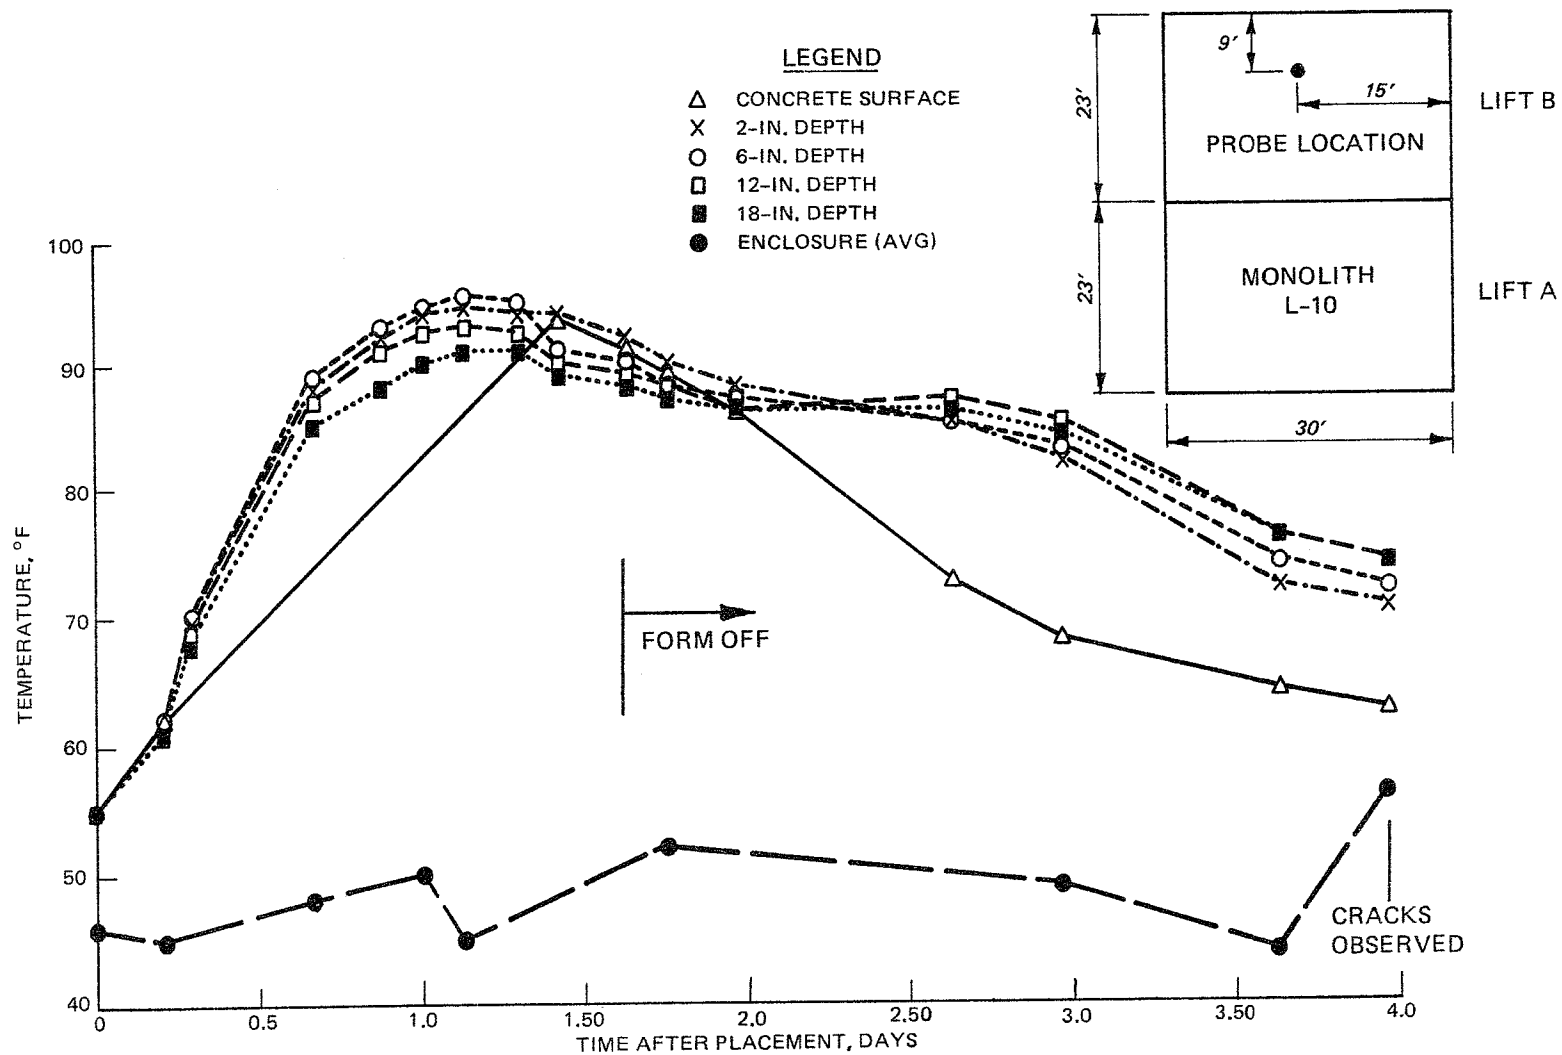
233. Results of the temperature monitoring of placement L-10B are shown in Figure 105. The peak temperature recorded, 27 hr following placement, was 96°F which represented a heat rise of 41°F. At the time of form removal, approximately 1-1/2 days after placement, the concrete was subjected to a temperature differential between ambient and 2-in. depth of approximately 40°F. This differential exceeded 25°F for two days following form removal. Although cracks were not observed until four days after placement, it was noted that they may have occurred earlier.

Figure 105. Results of temperature monitoring, mixture 78x517-4P5A5, placement L-10B, Lock No. 1, Mississippi River

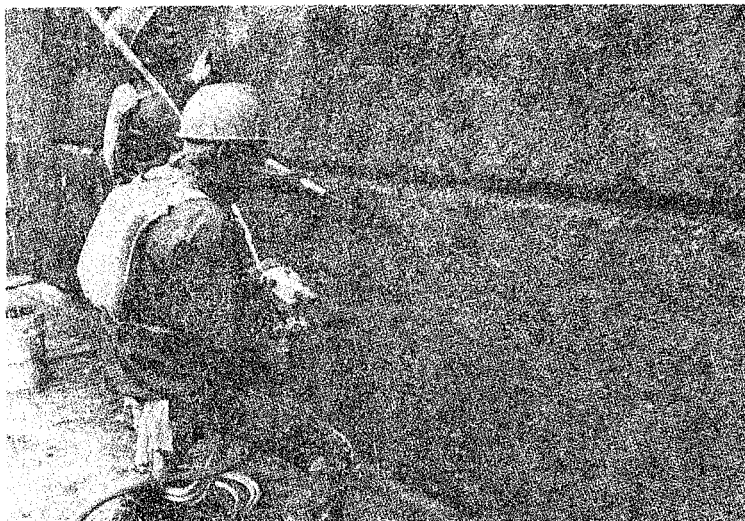
Figure 109. Application of latex-modified, glass fiber-reinforced shotcrete, Lower Monumental Lock

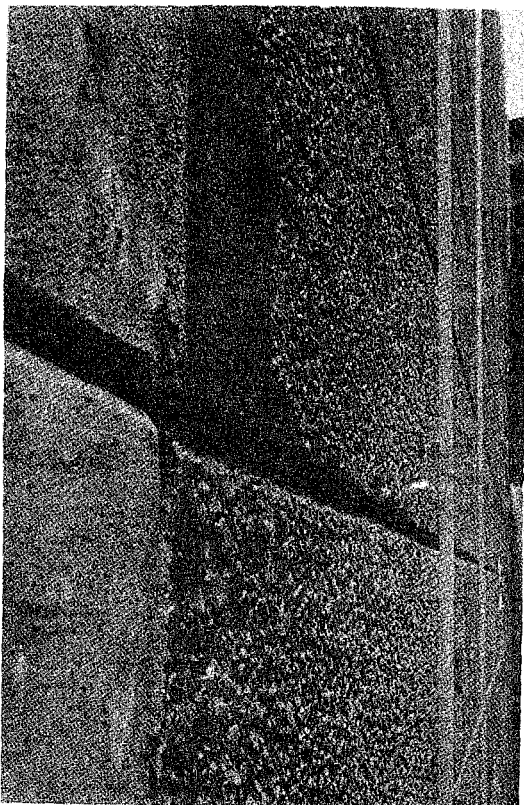
c. A portion of the test section nine months after the repair is shown in Figure 110. One year following completion of the trial repair the test sections were inspected to determine the condition of the various shotcrete mixtures. The condition of each section was described as follows:

Figure 110. Comparison of coated (left) and uncoated areas of wall, Lower Monumental Lock

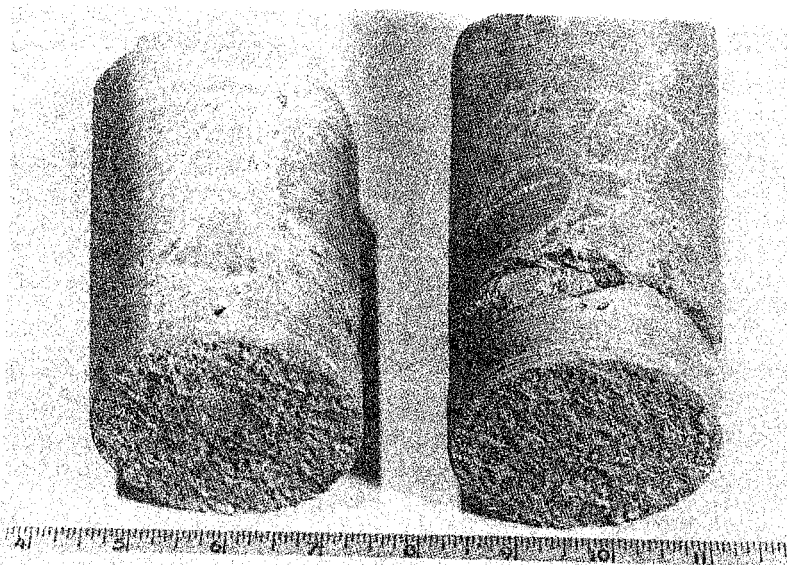
- (6) Mixture 6. No fine cracks were observed in this section. No debonded areas were evident on the upper lifts, but numerous hollow sounding areas were present in lower lift sections, with some sections having completely peeled off in large sheets. However, immediately next to some of the peeled-off areas, the bond of the coating to the substrate was excellent. As with all other sections, the surfaces of sections coated with Mixtures 5 and 6 showed essentially no change in appearance from the previous summer. Visual examinations of cores (Figure 111) indicated that hollow sounding areas were, in fact, delaminated, and the anticipated well-bonded zones were found to be sound. These observations confirmed that the debonding failures were caused by improper surface preparation. The coatings in such instances were found to be bonded to the mortar from the original (unsound) surface, but the weak surface mortar had peeled away from the rest of the concrete, thereby causing the failure.

Figure 111. Typical horizontal cores from test sections showing excellent bond (left) and bond failure at shotcrete-concrete interface (right) due to improper surface preparation, Lower Monumental Lock

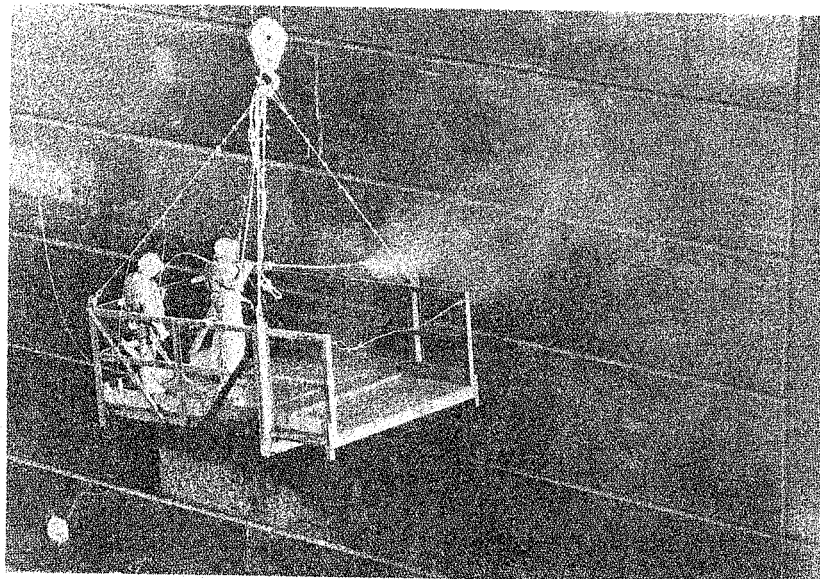
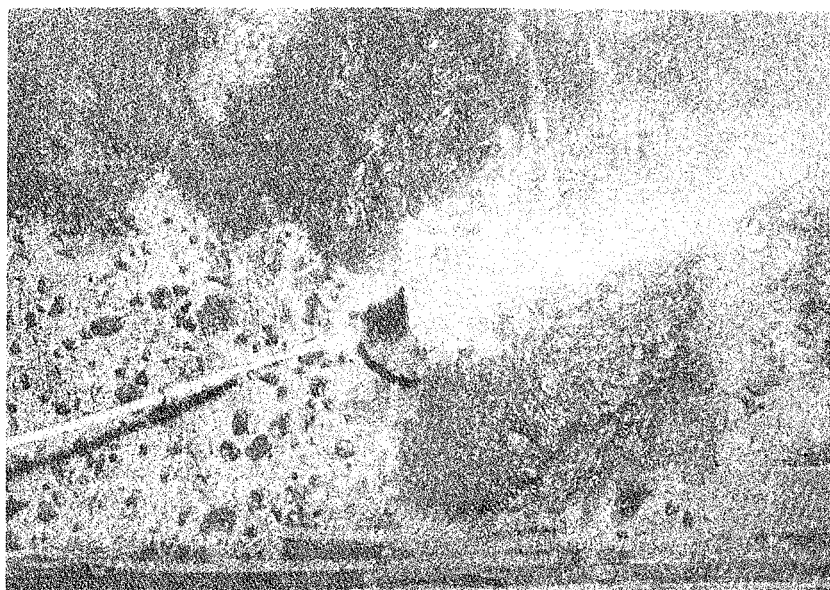
Figure 112. Removal of unsound concrete mortar using a high-pressure water jet, Lower Monumental Lock

the lock chamber walls. Since the success of the repair was totally dependent upon satisfactory surface preparation, several additional surface cleaning trials were made to verify that with properly operating high-pressure water-jet equipment, the surface could be satisfactorily cleaned. Sandblasting equipment, wire brushes, hand chipping, and air-operated scabblers were also tried by the Government designers. The benefit of this experience was passed on to the bidders through a prebid conference, discussion in the technical provisions of the bidding documents, and with photographs of the work (Figure 112) which also became a part of the bidding documents.
